**BLACKSTONE RIVER BASIN  
WORCESTER, MASSACHUSETTS**

**BELL POND DAM  
MA 00148**

# **PHASE I INSPECTION REPORT NATIONAL DAM INSPECTION PROGRAM**

**OCTOBER 1978**

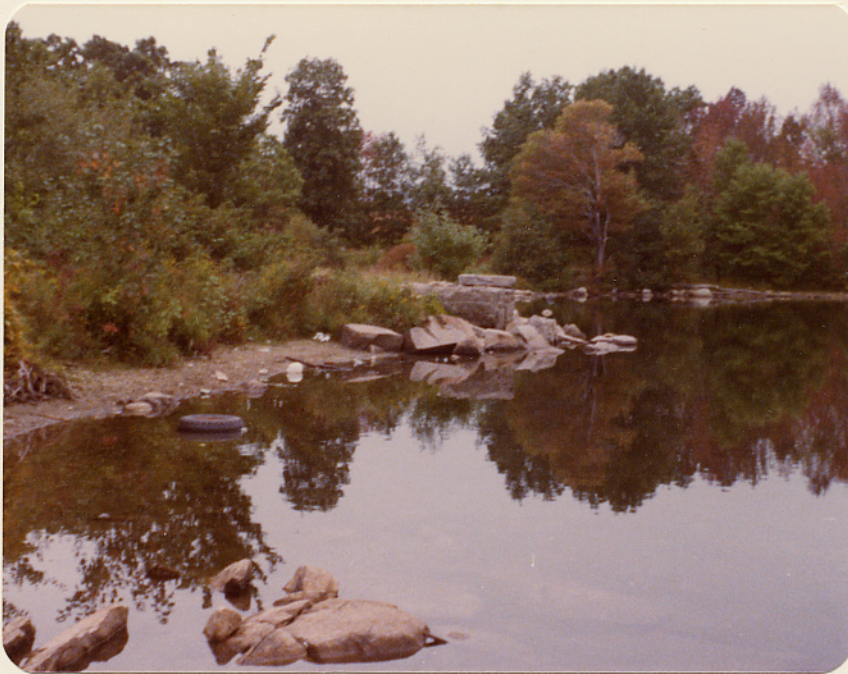
**VIEW OF UPSTREAM FACE OF DAM**

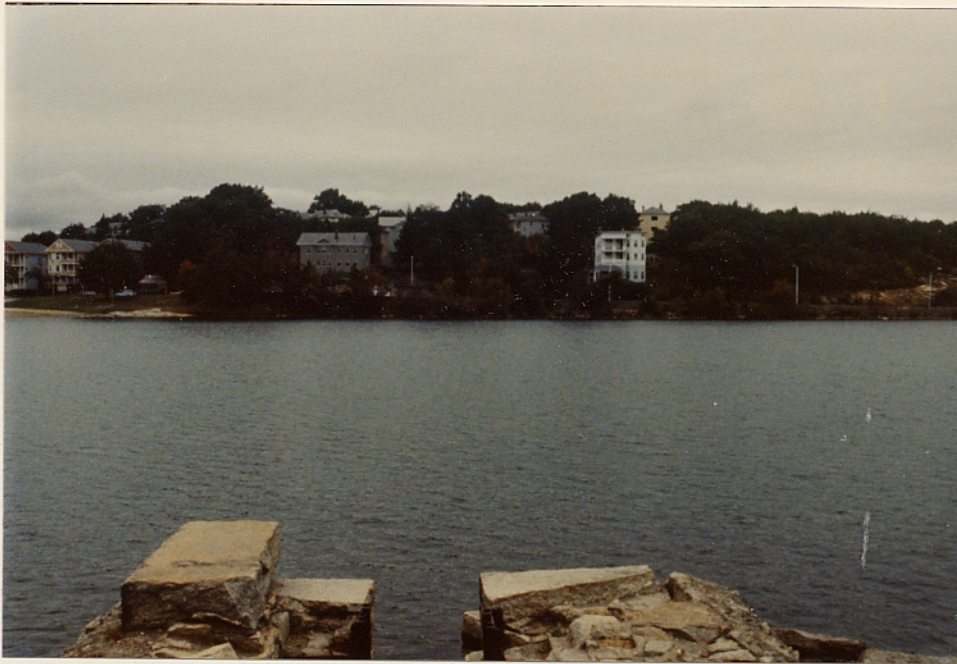
**NO. 1 VIEW OF POND FROM ABANDONED OUTLET**

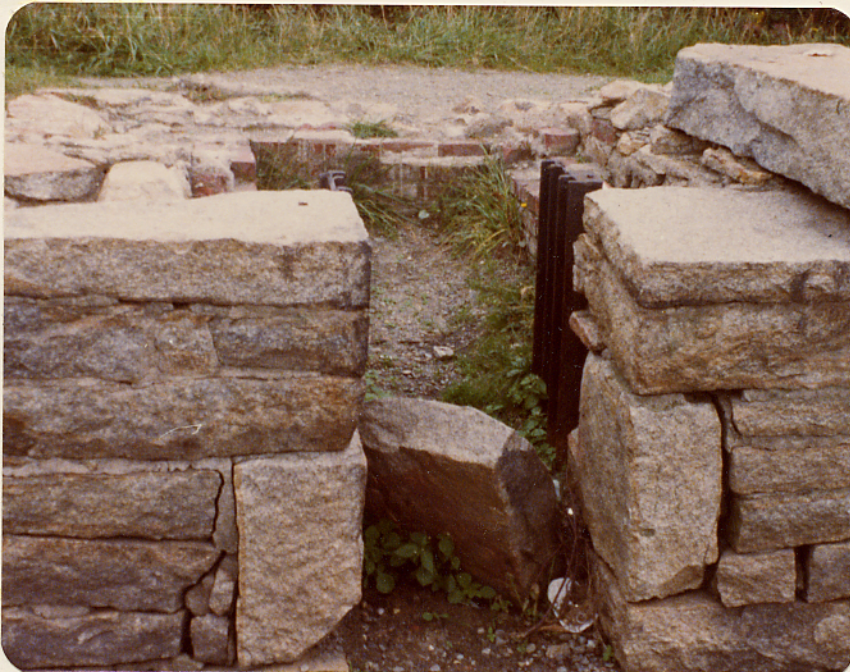
The foundation of an abandoned gate house is located near the midpoint of the dam on the upstream face. The foundation is 11 feet square in size and constructed of mortared granite blocks with an interior lining of brick. There is an opening in the upstream wall which contains iron guides for two sets of flashboards. The interior of the gate house has been backfilled with soil, and the flashboards are gone.

**NO. 2 VIEW OF ABANDONED OUTLET STRUCTURE**

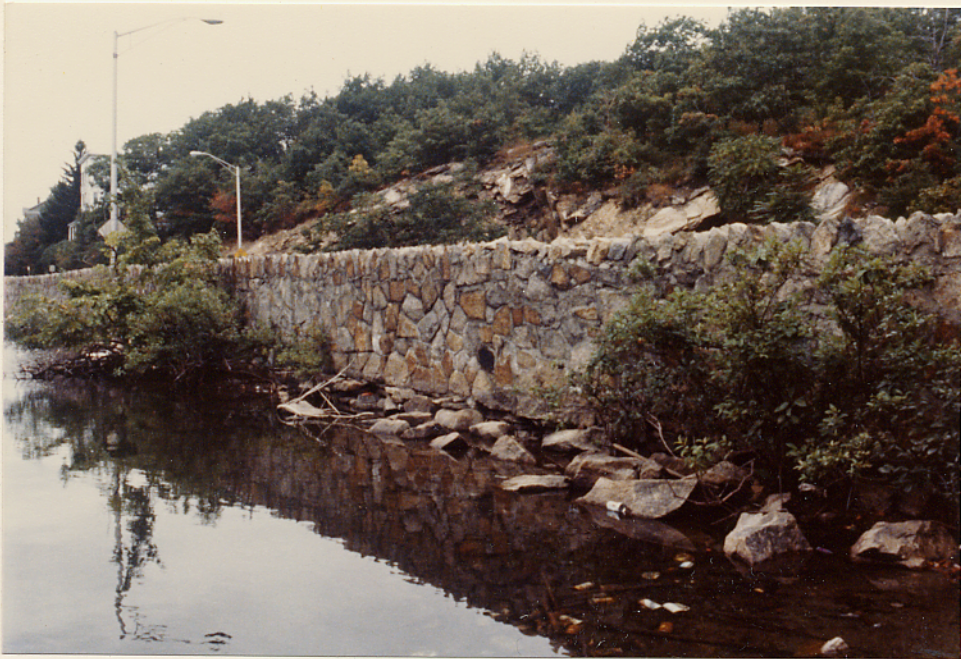
**NO. 3 VIEW OF STONE RETAINING WALL ALONG BELMONT STREET**

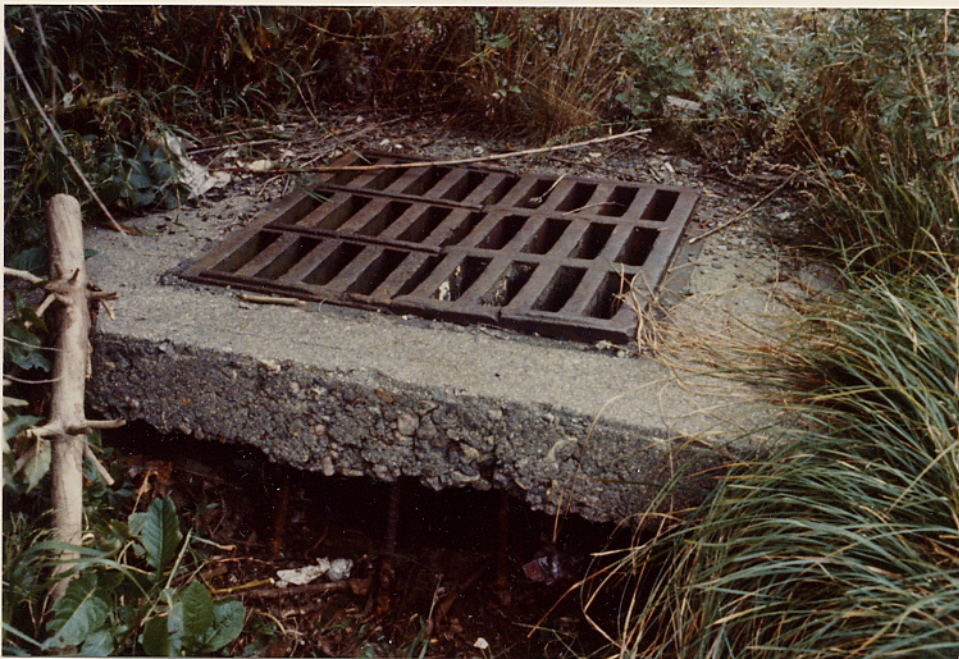
- c. Appurtenant Structures. The only spillway is a catch basin and outlet pipe at the northeast corner of the pond. The catch basin and upstream end of the pipe are clogged with soil, leaves and trash. In its present condition, the outlet is practically inoperable. The land around the outlet is low in elevation, and there is only about 1.3 feet of freeboard above the invert of the conduit (El 668.8).
- d. Reservoir Area. The area around the pond is mostly a park, and the only structures are a bath house at the northeast corner and a small commercial building near the northeast

- 4.3 Maintenance of Operating Facilities. The catch basin and outlet pipe are clogged with soil, leaves and trash. In the present condition, flow in the pipe is severely restricted. There is no low-level outlet at this dam to draw down the pond in an emergency.

**NO. 4 VIEW OF CATCH BASIN AT NORTHEAST CORNER OF POND**

It is recommended that the Owner employ the services of a qualified consultant to design a low level outlet for the pond. In addition, the Owner should accomplish the following: remove accumulated debris from the catch basin and outlet pipe; control seepage at the toe of the dam; clear trees and brush from the slopes of the embankment; and repair the concrete and remove debris at the stormwater drainage basin below the erosion control channels. The Owner should also implement a systematic program of inspection and maintenance.

Removal of debris from the catch basin and outlet pipe should be undertaken by the Owner within six months of receipt of this Phase I Inspection Report. The other recommendations and remedial measures described above and in Section 7 should be implemented by the Owner within a period of two years. An alternative to these recommendations would be to breach or remove the dam.

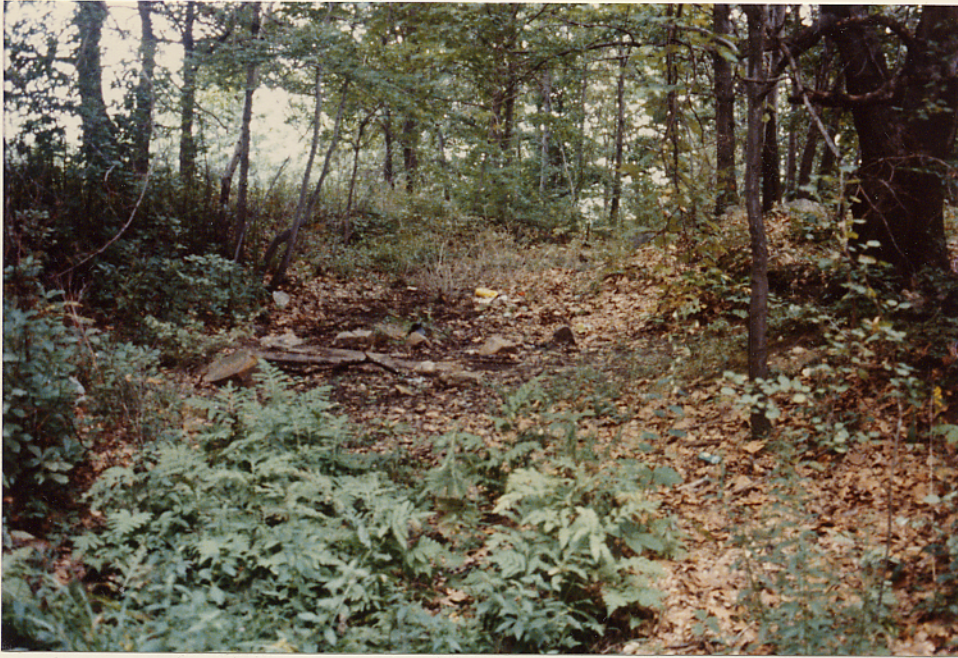
- e. Downstream Channel. The channel downstream of the dam is an unlined earth channel with sloping sides. The floor of the channel is moist and contains organic material. The sides are densely overgrown with trees. There is a gate valve stem protruding from the floor of the channel about 80 feet downstream of the dam. Below Chandler Hill, the floor as well as the sides of the channel are overgrown with trees. The concrete on the erosion control channels is cracked and spalled in some places. Sections of the channels contain an accumulation of leaves and soil up to a foot thick. The concrete on the stormwater drainage basin at the bottom of the hill is severely eroded and crumbling. There is an accumulation of leaves and other debris in the trash racks on the sides of the basin.

NO. 5 VIEW OF EARTH CHANNEL DOWNSTREAM OF OUTLET

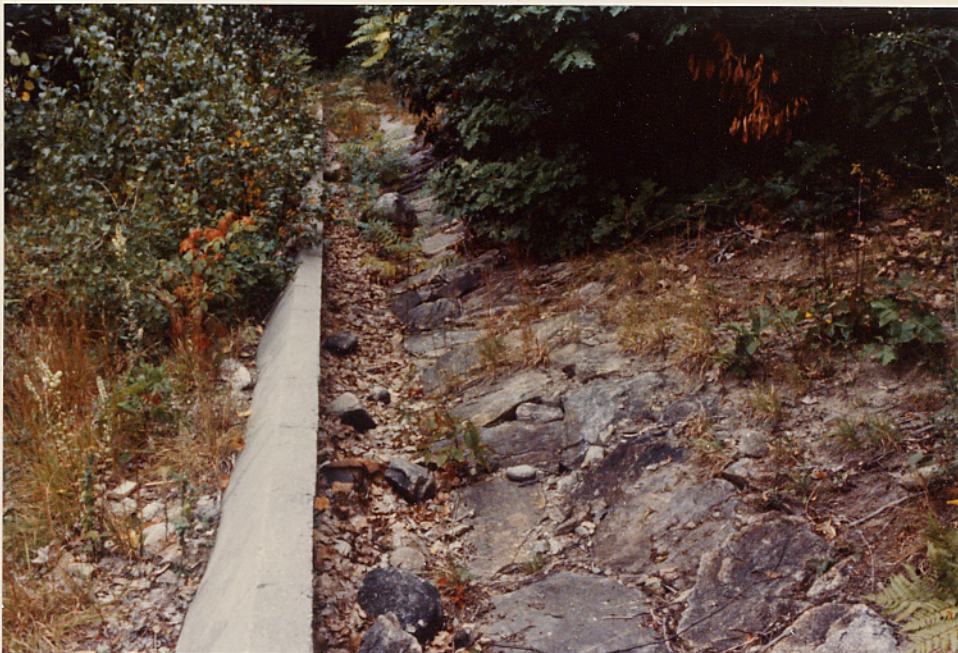
NO. 6 VIEW OF CONCRETE WALL FOR EROSION CONTROL

- (3) clear trees and brush from the downstream slope of the dam, and brush from the upstream slope of the dam
  - (4) repair deteriorating concrete on the stormwater drainage basin at the bottom of the erosion control channels, and remove accumulated debris from the trash racks on the sides of the basin.
